Note: This is what we refer to as Tank #2

## WATER TANK INSPECTION REPORT

Town, City, Agency: La Mesa Water      Date: 11/7/2020

**Tank#: 1**      Tank Capacity: 200K      Dia.: 55      High: 14

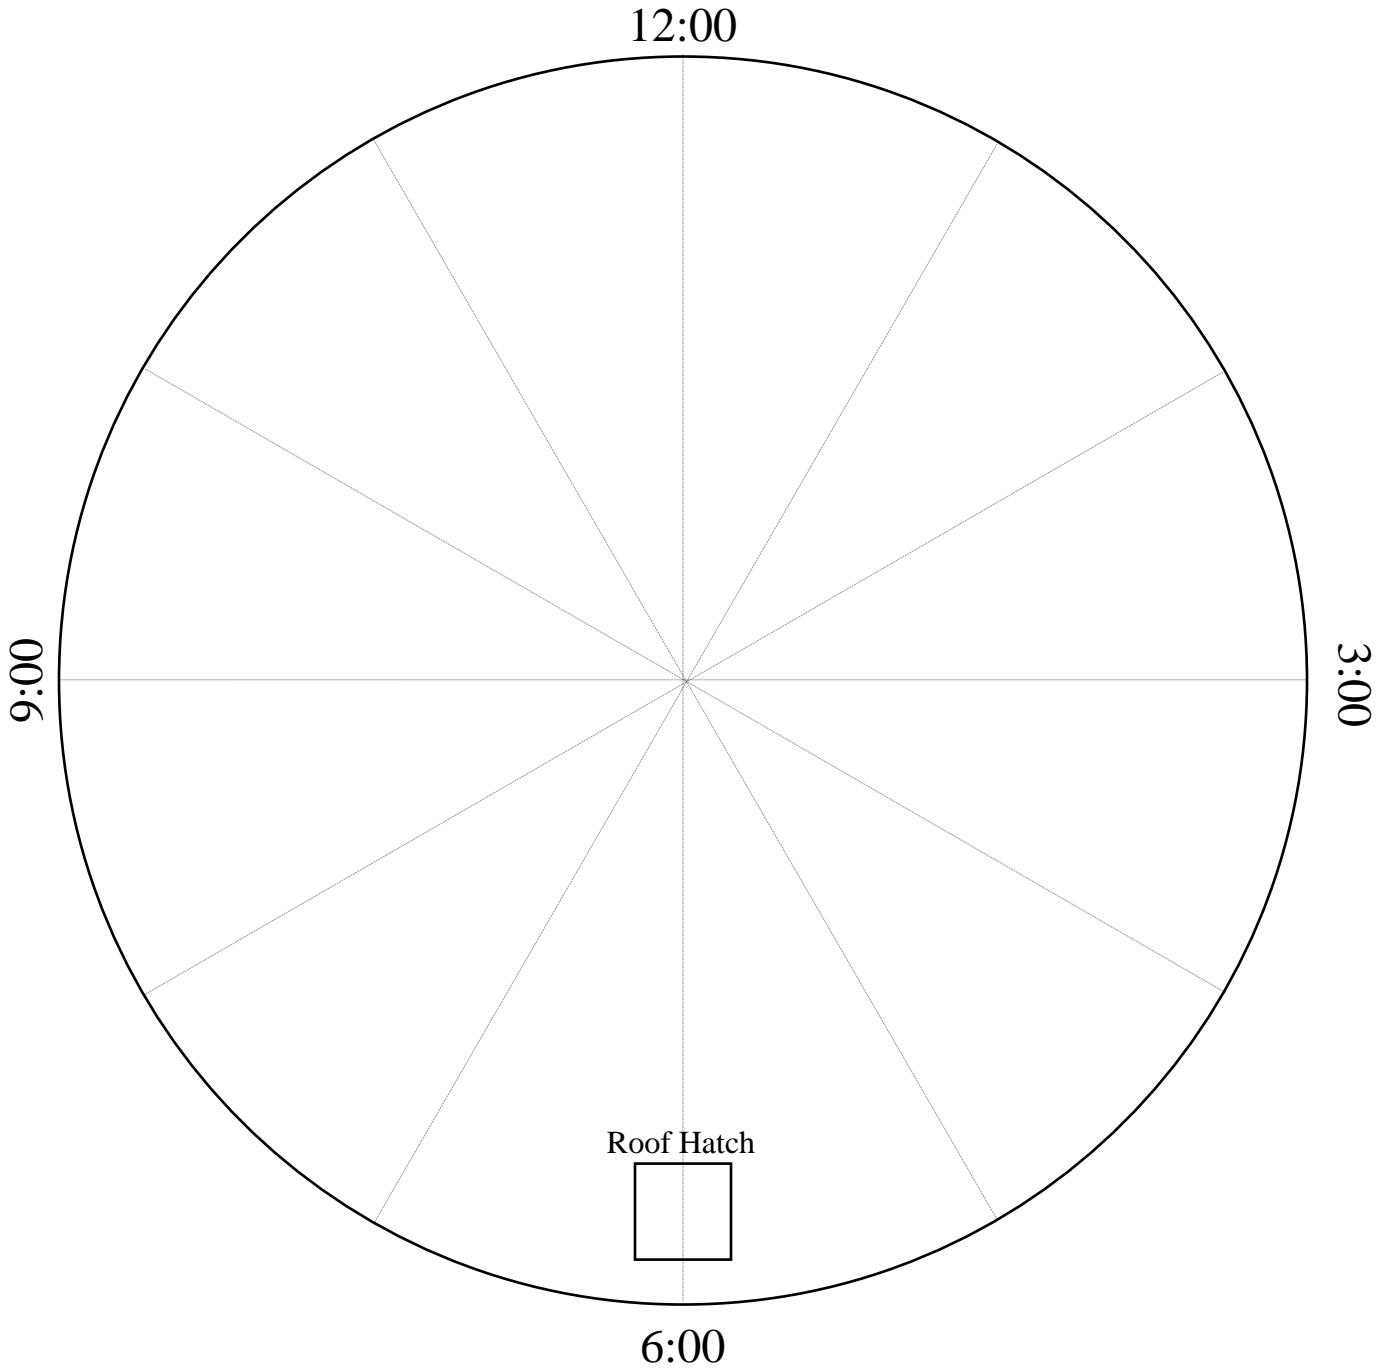
**Storage Tank Internal Penetration Layout**

Inlet Position: 6:30      Outlet Position: 6:30      Drain Position: 7:00

Over Flow Position: 7:00      Shell Manways: 9:00 / 3:00
