RE: 2022 Sanitary Survey Report

SANITARY SURVEY REPORT

**La Mesa Water CO-OP
NM3500123**

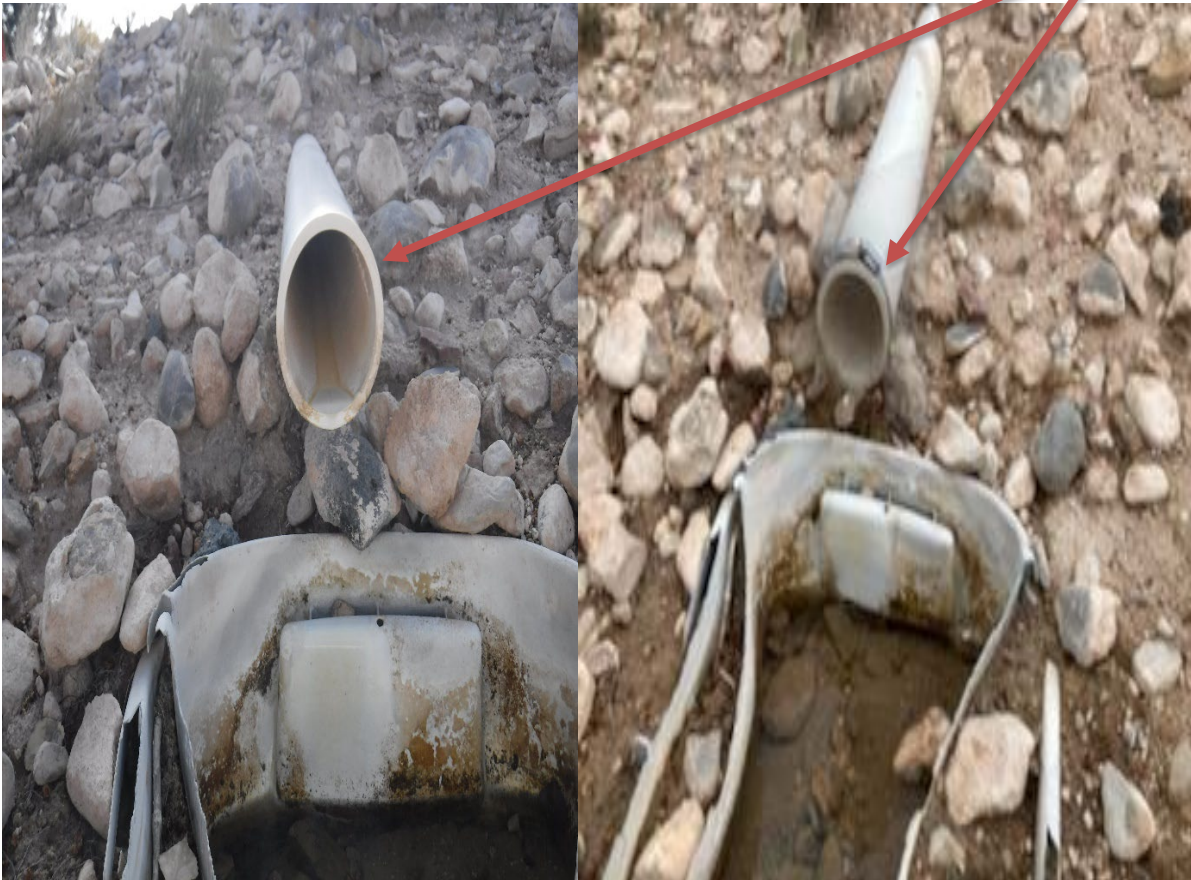
- Notes & Recommendations:** Well #6 floor drain piping for La Mesa Water CO-OP appeared to be needing a screen with 24-gauge non-corrosive to prevent vermin and insects from entering.

Recommended Action: The La Mesa Water CO-OP recommendation to place a 24-gauge wire mesh for Well #6 floor drain pvc pipe was **Corrected on December 20, 2022.**

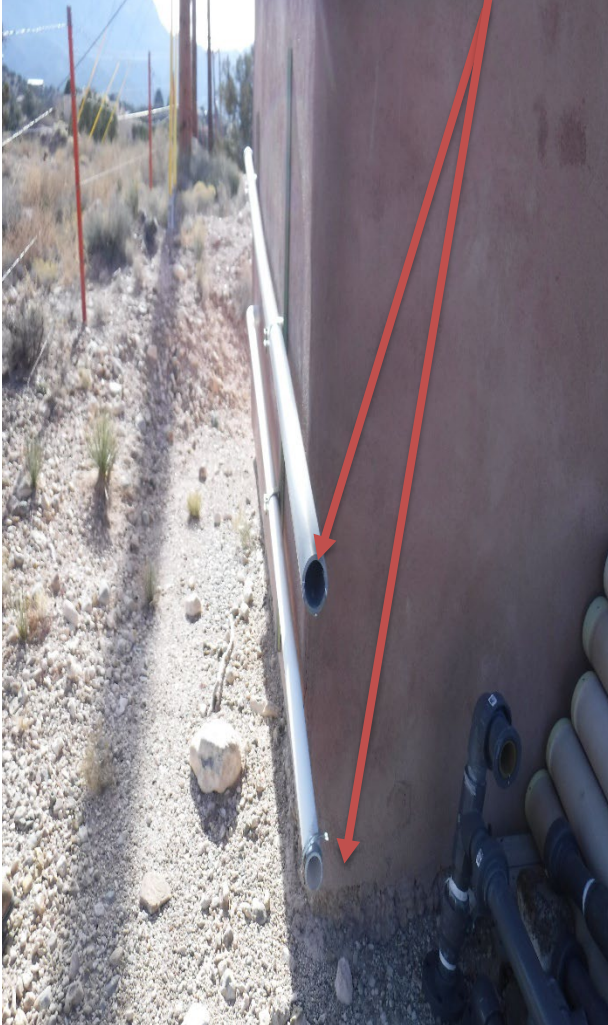
2. **Notes & Recommendations:** Well #6 flush line and PRV piping for La Mesa Water CO-OP appeared to be needing screens to be replaced or added with 24-gauge non-corrosive to prevent vermin and insects from entering.

Lacking screen or needs to be replaced.

Recommended Action: The La Mesa Water CO-OP recommendation to place a 24-gauge wire mesh screen and replace the flush line and PRV piping screens were **Corrected on December 20, 2022.**

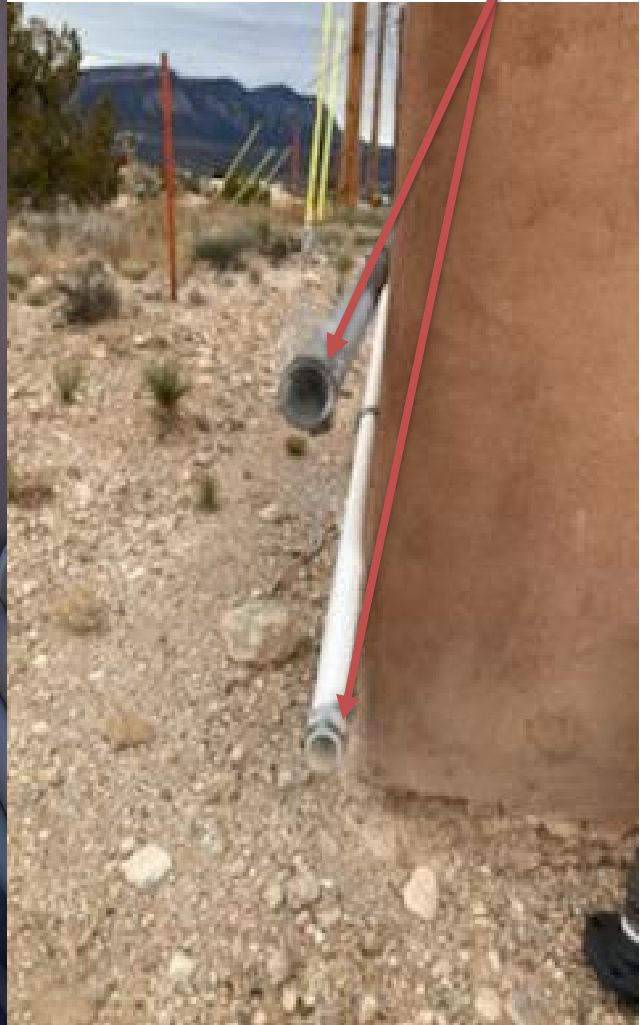
Screens have been replaced and added.

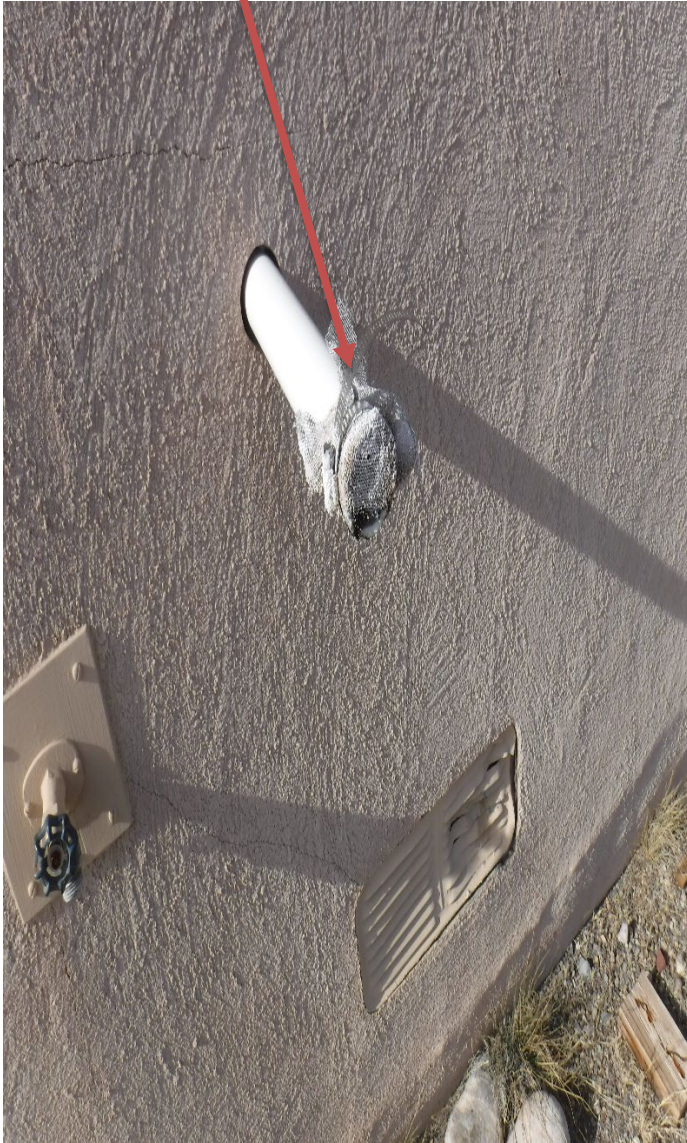
3. **Notes & Recommendations:** Well #5 PRV relief line piping for La Mesa Water CO-OP appeared to be needing a screen to be replaced with 24-gauge non-corrosive to prevent vermin and insects from entering.

Needs new screen

Recommended Action: Well #5 PRV relief line piping for La Mesa Water CO-OP screen was replaced with a new 24-gauge wire mesh screen was **Corrected on December 20, 2022.**

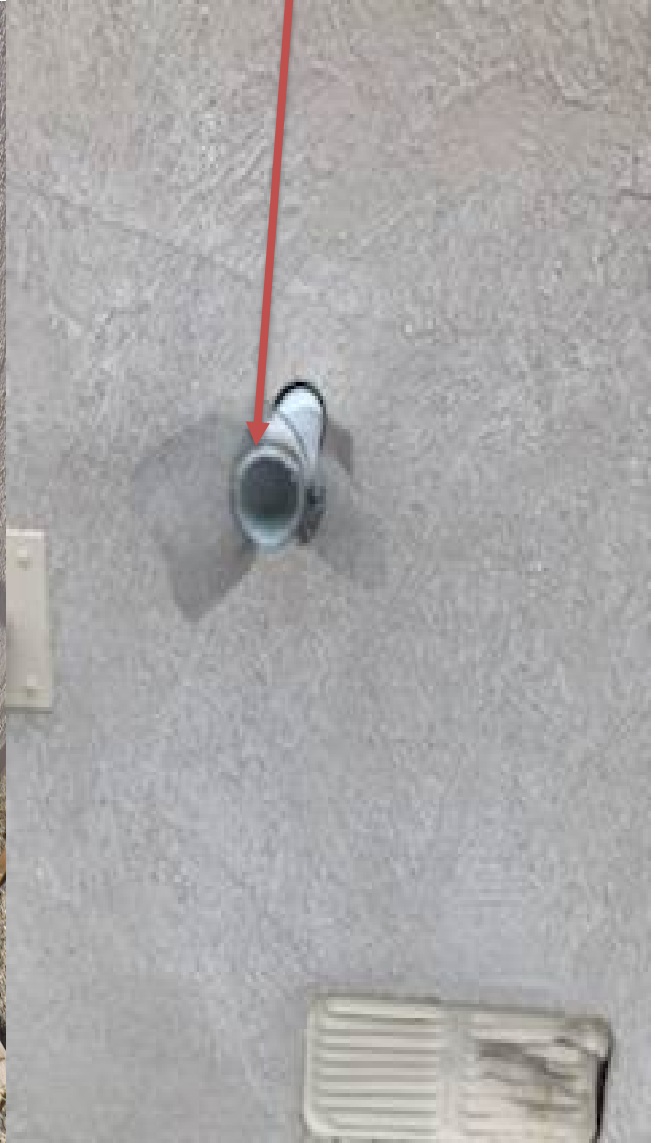
New screen replaced

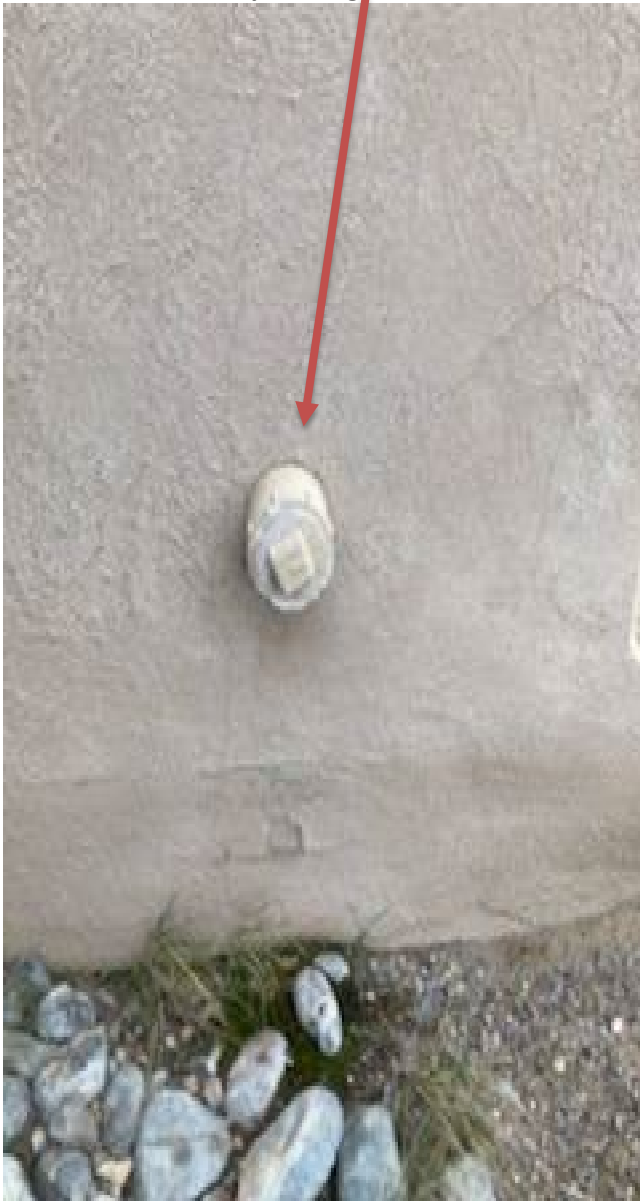
4. **Notes & Recommendations:** Well #5 flush line cap for La Mesa Water CO-OP appeared to be needing to be replace or tighten.

Well #5 Flush line cap leaking

Recommended Action: Well #5 flush line cap for La Mesa Water CO-OP was tighten. **Corrected on December 20, 2022.**

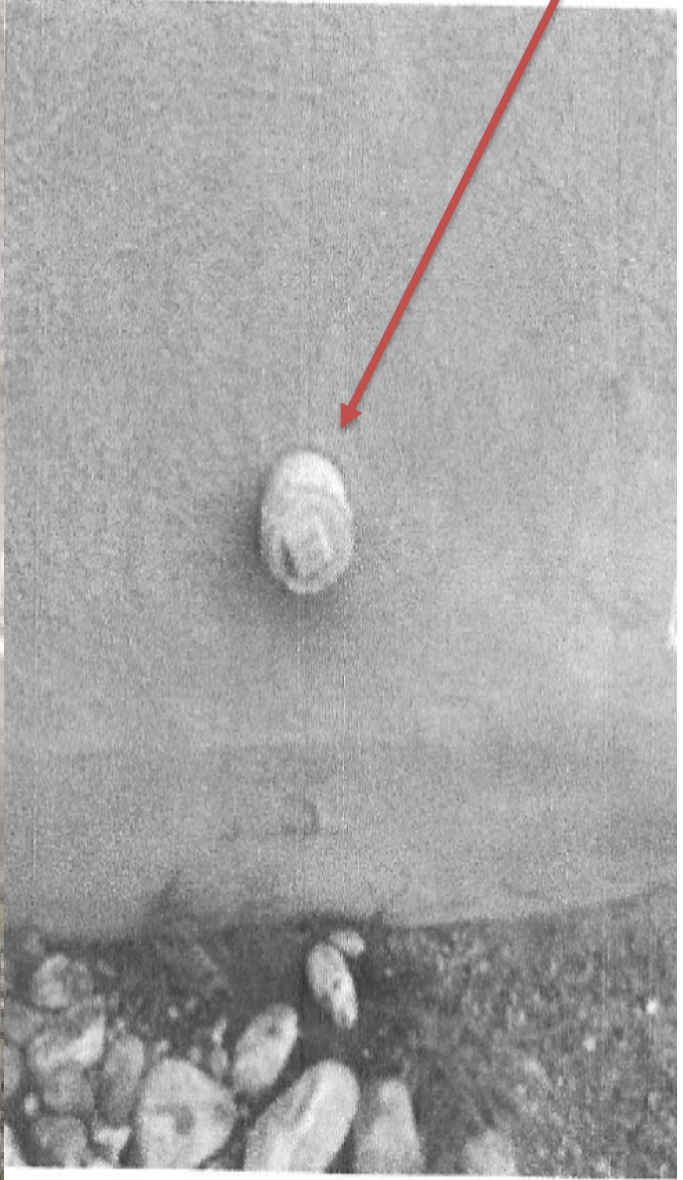
Well #5 Flush line cap tighten to stop leaking

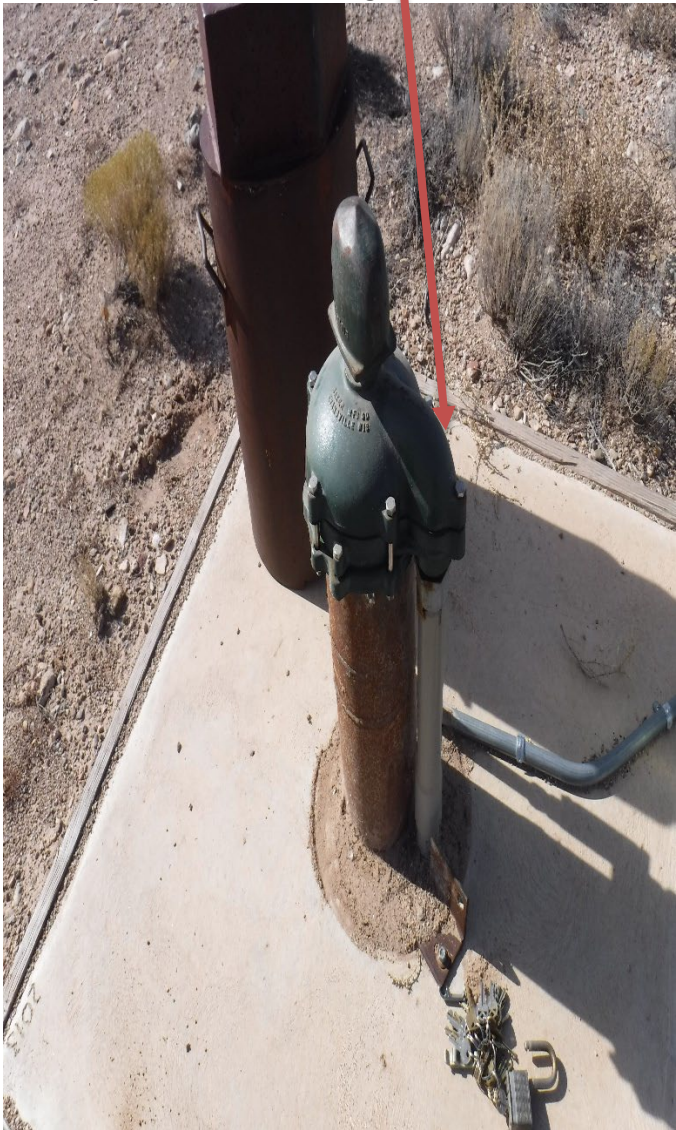
5. **Notes & Recommendations:** Well #6 well cap cover bolts were loose or missing for La Mesa Water CO-OP and they are needing to be replaced or tighten.

Well cap bolts loose or missing

Recommended Action: Well #6 well cap cover bolts for La Mesa Water CO-OP were tighten and or replaced. **Corrected on December 20, 2022.**

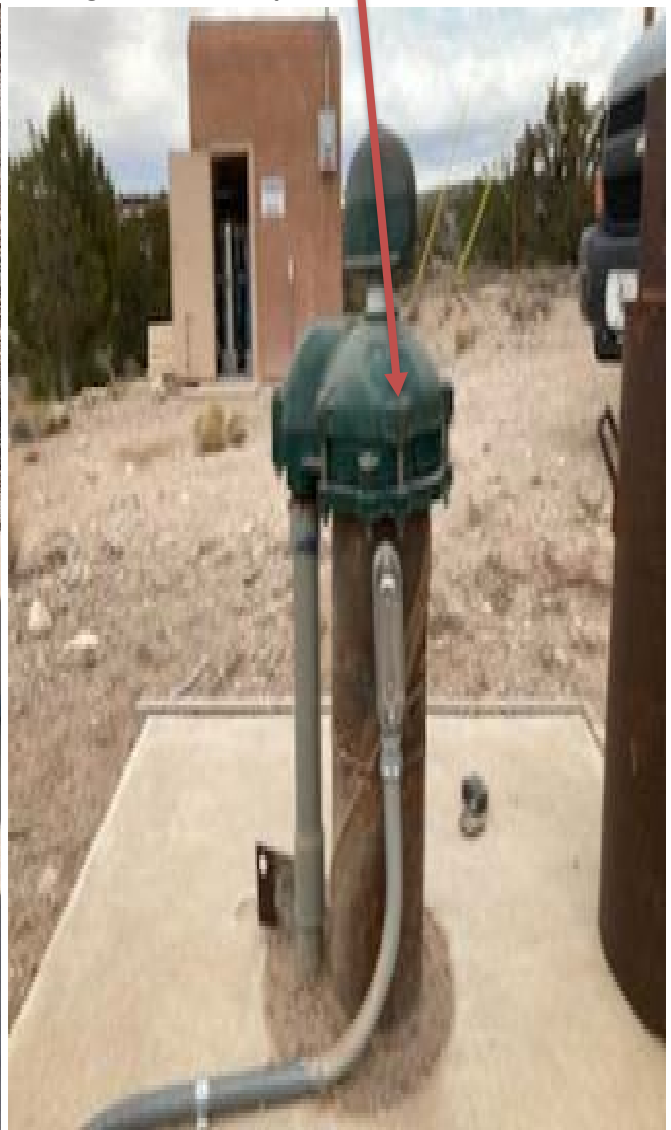
Bolts tighten and or replaced
