# Source information Hote: Shaded fields are required for data entry

-	-			Takana ang						1	
PWSS#:	001-23	Water Su	poly System Na	us:	La Mesa Water Cooperative DATE: 10							10/13/2
WSF ID#		Water Su	pply Facility Nar	ne:	Well 5							
	Source	Codes						Basic Well Infor				<b>_</b>
Water Typ	e Code:		GW	SEO Well#	:	RG 49802-S	4 Screen Depth	(ft.)	320-650' & 690- 750'	Gravel F	Pack Depth: (ft.)	205'
Facility Tyr	oe Code:		WL	Date Equip	ped:	7/19/20	06 Casing Type:	Casing Type: Steel Type o			Ритр:	Submersible
Activity Co	de: (I,A)		A	Well Depth:	: (ft)	755	Casing Diame	Casing Diameter: (in.) 6" Pump		Pump S	etting: (ft.)	493'
	Code: (P.A.E.	etc.)	P	Static Wate	r Levek (ft)	272'	Casing Depth	(ft.) (	560.	Pump C	apacity: (gal/min)	65
Date Cons	te Constructed: 6/19/2006 Drawdon					Unknown 4	Depth of Grou	t: (fl.)	195'	Wellhea	d Elevation:	Unknown
	and the contract of the contra					We	Il Conditions	4,1	16.5		. in	
ls site sec	urity adequate?	(p 4-5)		Section of the sectio	No, no fen well cover	ce, has locke	Does the casi	Does the casing extend at least 18" above ground level?				Yes [7"

### Sanitary Survey Form

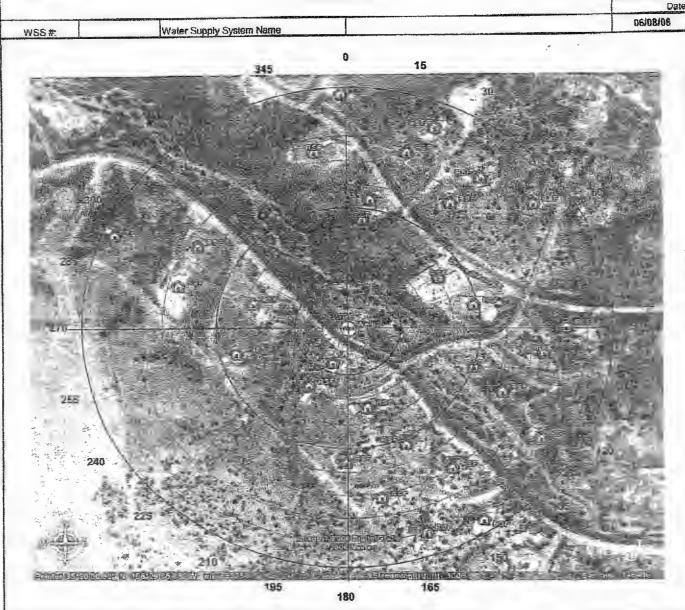
### Contaminate Plot

Code	Description	Distance	Code	Description	Distance
RSF	DOMESTIC SEPTIC				
ADC:	ARROYO				
<del></del>

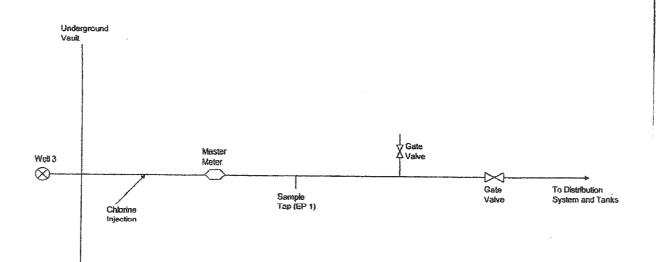
#### Well/Pumphouse Schematic

PWSS#:	NM35001-23	Water Supply System Name	La Mesa Water Cooperative	Dale:	10/13/2009
WSF#		Water System Facility Name	Well 3

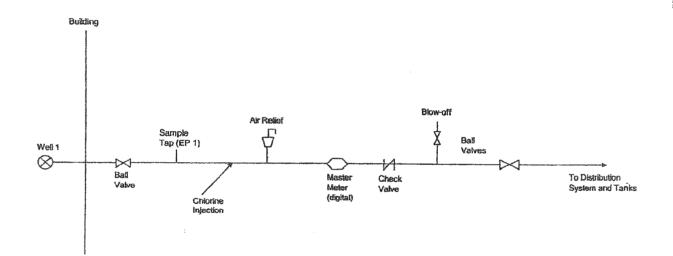
#### Well/Pumphouse Schematic

i					
	PWSS#:	NM35001-23	Water Supply System Name	La Mesa Water Cooperative	Date: 10/13/2009
-	WSF#		Water System Farith Name	I a Mesa Wajer Connerative

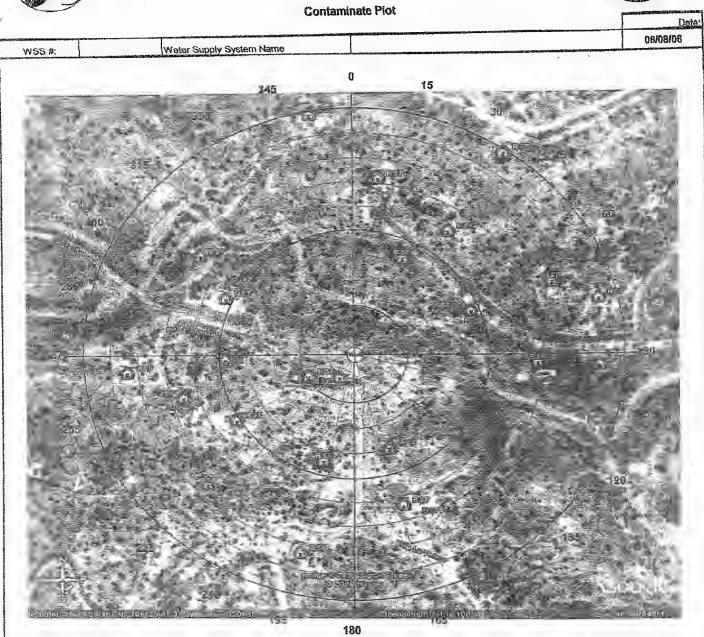
LIST CONTAMENAL	NT SOURCE, DESCRIPTI	ON AND DISTANCE F	ROM WATER SOURCE	
Code	Description	Distance	Code	Description	Distance
RSF	DOMESTIC SEPTIC				-
ADC	ARROYO			·

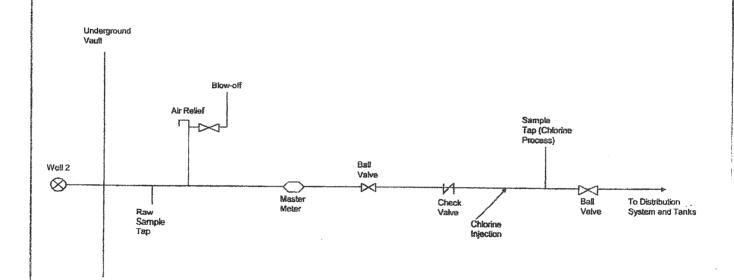
#### Well/Pumphouse Schematic

STATE OF THE PROPERTY OF THE P	V. V				1
1	PWSS#:	NM35001-23	Water Supply System Name	La Mesa Water Cooperative	Date: 10/13/2009

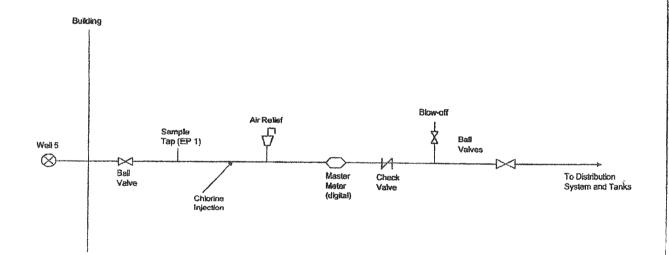
#### Well/Pumphouse Schematic

PWSS #:	NM35001-23	Water Supply System Name	La Mesa Water Cooperative	Date:	10/13/2009
wor a					
WSF#		Water System Facility Name	IWell 5

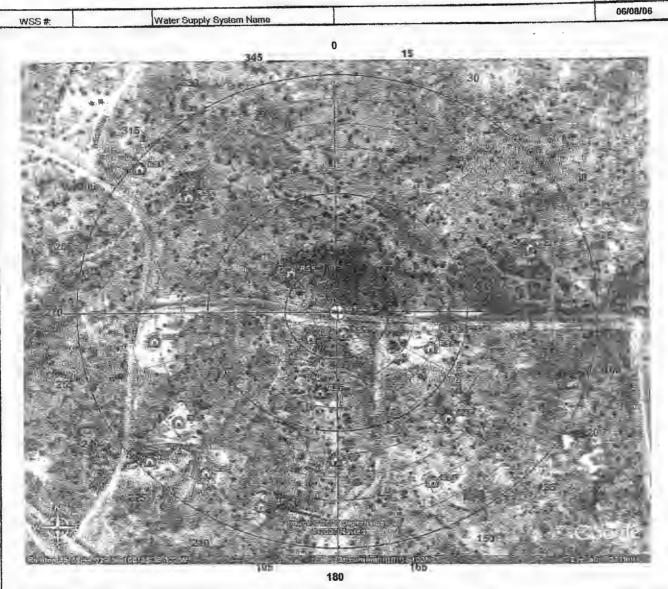
# Contaminate Plot

Description Distance Code Description Distance

RSF DOMESTIC SEPTIC
