RE: 2017 Sanitary Survey Report

SANITARY SURVEY REPORT

**La Mesa Water Coop
NM3500123**

NMED - Drinking Water Bureau System Schematic La Mesa Water Coop NM3500123

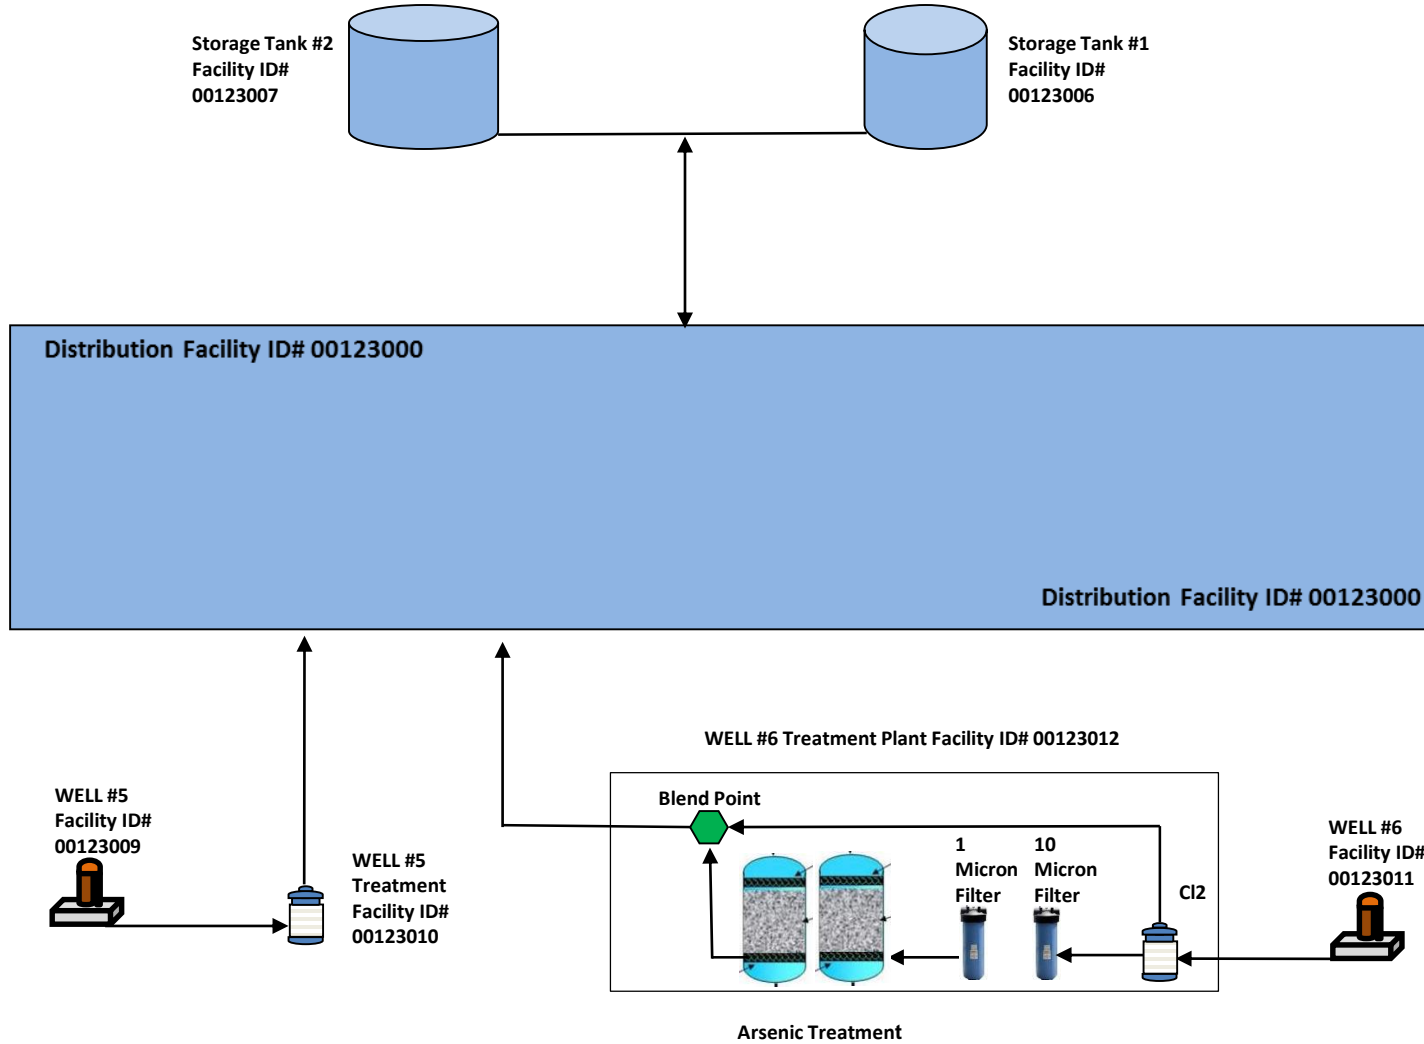
The La Mesa Water Coop water system has approximately 650 year round residents and is classified as a Community water system according to the New Mexico Drinking Water Regulations 20.7.10 NMAC. The water system consists of two wells (Well #5 and Well #6, two filters, an arsenic treatment unit, two chlorination units, two storage tanks (Tank #1 and Tank #2), and distribution. The storage tanks are bolted steel tanks, Tank #1 has a capacity of 100,000 gallons and Tank #2 has a capacity of 200,000 gallons. The storage tanks are plumbed to “float” on the distribution system. The distribution system consists of approximately 55,000 feet of pipe and 233 metered connections. The two wells currently produce enough water to meet an average demand of .06 million gallons per day (MGD).
