Memorandum

To: NMED – Drinking Water Quality Bureau
From: Brian Ambrogi PE,
CC: Jock Embry – President La Mesa Water Cooperative
Date: 10/01/2020 **File Number:** 16-600-204-00
Re: Engineering Summary – La Mesa Water Cooperative Well #3 Arsenic Treatment Facility

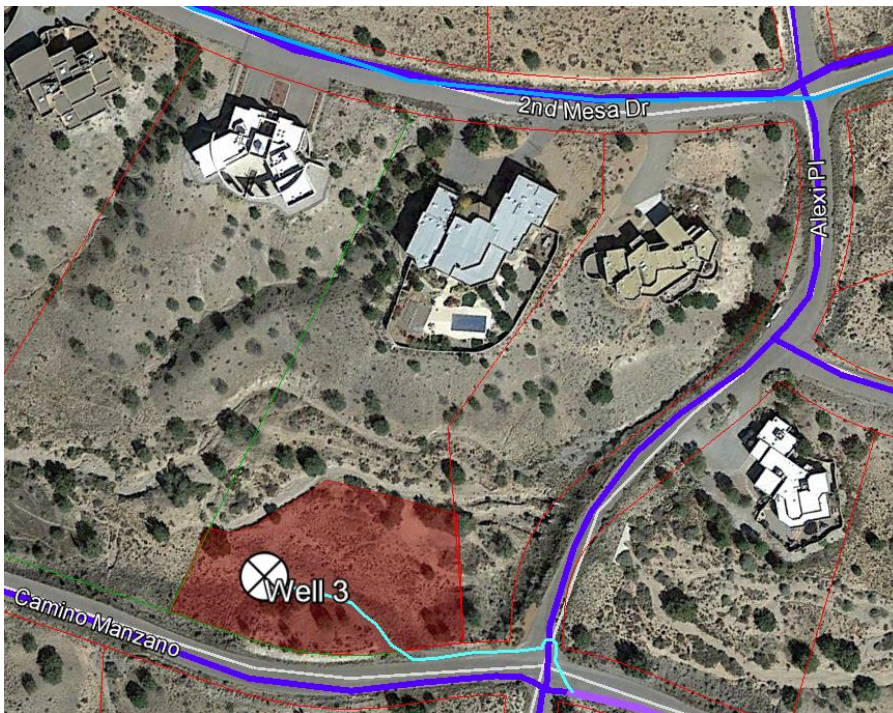
Figure 1 - Well #3 Location and Usable Area

Well #3 is located at 64 Camino Manzano in Sundance Mesa. The site is 0.1818 acres or 7,919 square feet in size with approximately 77 feet width along the front roadside. The depth of the lot ranges at approximately 79-80 feet. The rear property line is approximately 100 feet wide. There is a separate 20-foot access road easement on the adjacent eastern property. The north side of the property is bordered by an unnamed arroyo. Standard Sandoval County road setbacks apply and there is an electric easement along the front of the property. See figure 1.

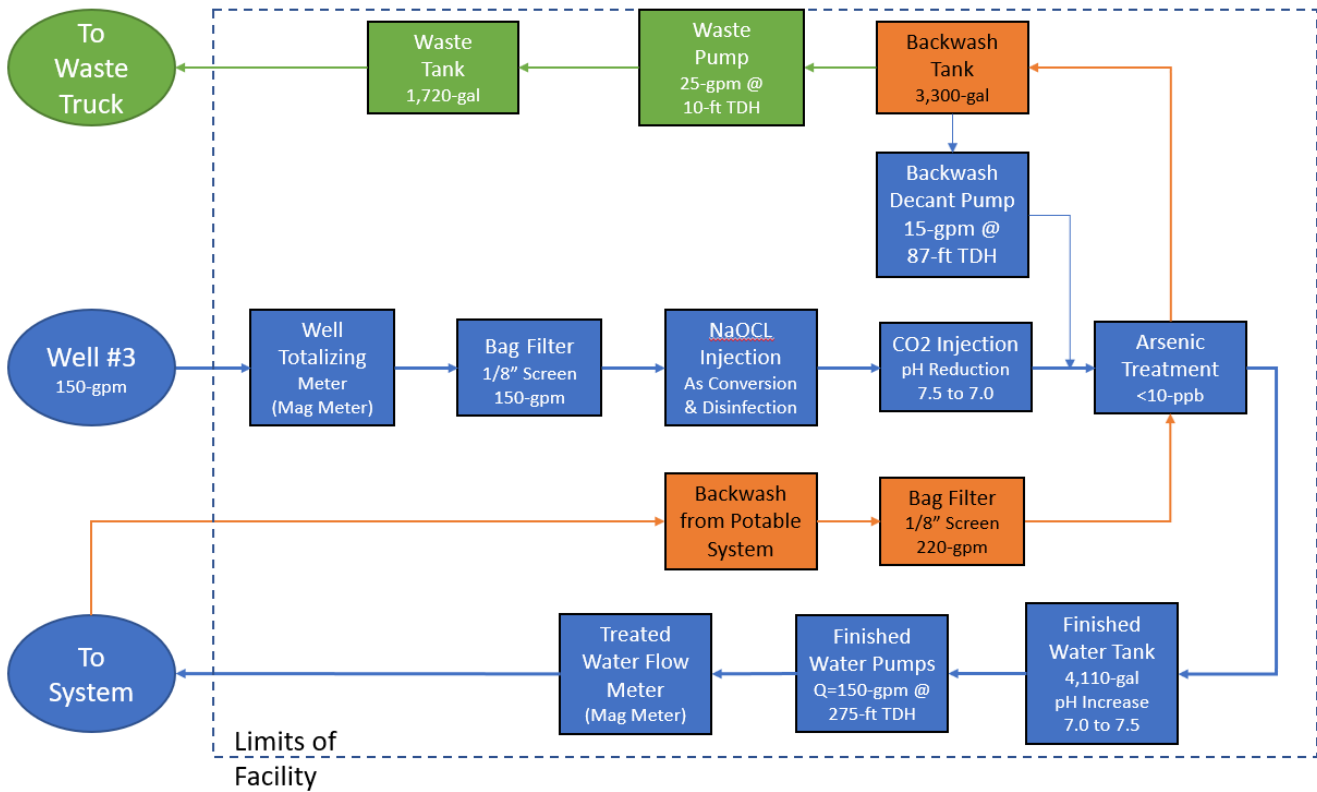
The ATS shall be able to remove arsenic below the MCL threshold of 10-ppb, with a goal to not exceed 8-ppb in the treated water. Operation of the ATS will be dependent on the operation of the Well #3 pump and called to start when the pump starts. Raw water from the well will be conveyed to the treatment building through a 4-inch C-900 PVC pipe to the ATS building. The following Process Flow Diagram illustrates the flow paths for treatment (blue), backwash (orange), and waste stream (green) within the ATS facility.

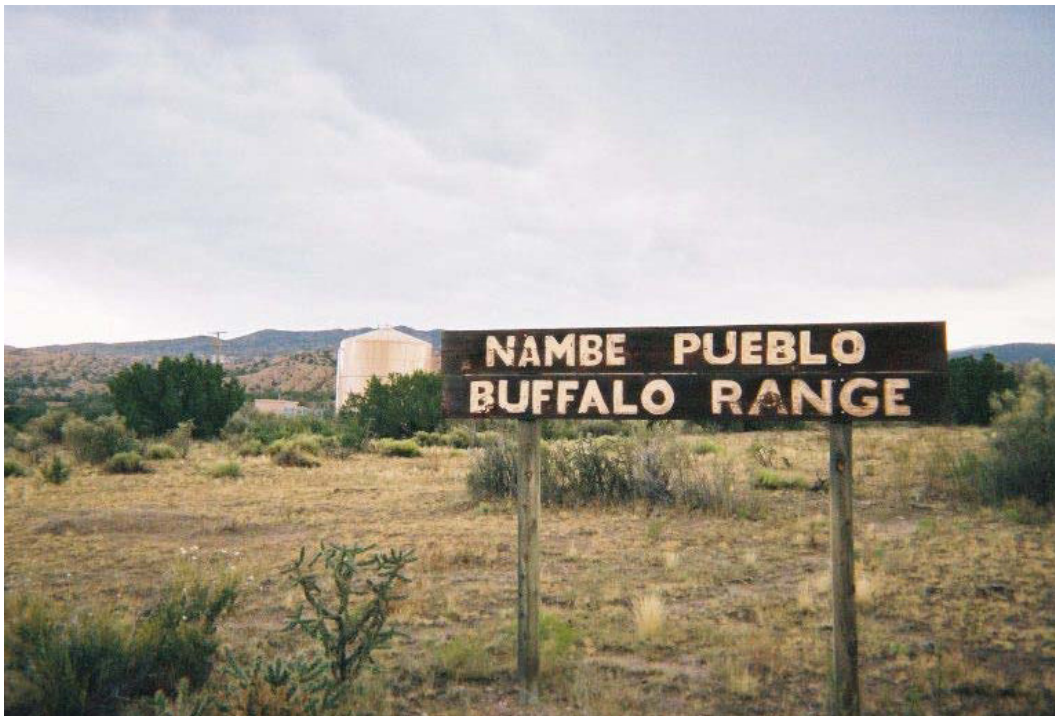
Figure 4-1. Nambe Pueblo Buffalo Range

The Nambe Pueblo water system supplied drinking water to approximately 500 community members with 150 service connections. Located on a hilltop adjacent to a buffalo range (Figure 4-1), the pre-existing system consisted of a 145-gpm well (Buffalo Well [Figure 4-2]), a pump house (located about 10 ft from the well), and a 17-ft-diameter, 24-ft-tall water storage tank (Figure 4-3). Groundwater was pumped intermittently from the well to the pump house where a totalizer was used to track the total volume of feed water to the system. Liquid chlorine was added (Figure 4-4) using a peristaltic pump to maintain a residual chlorine level of approximately 0.58 mg/L (as Cl₂) in the 40,000-gal water storage tank and distribution system. Water in the storage tank was gravity-fed through the distribution system to the community. The system typically operated for 3 to 4 hr/day, with a daily demand of approximately 34,000 gpd.

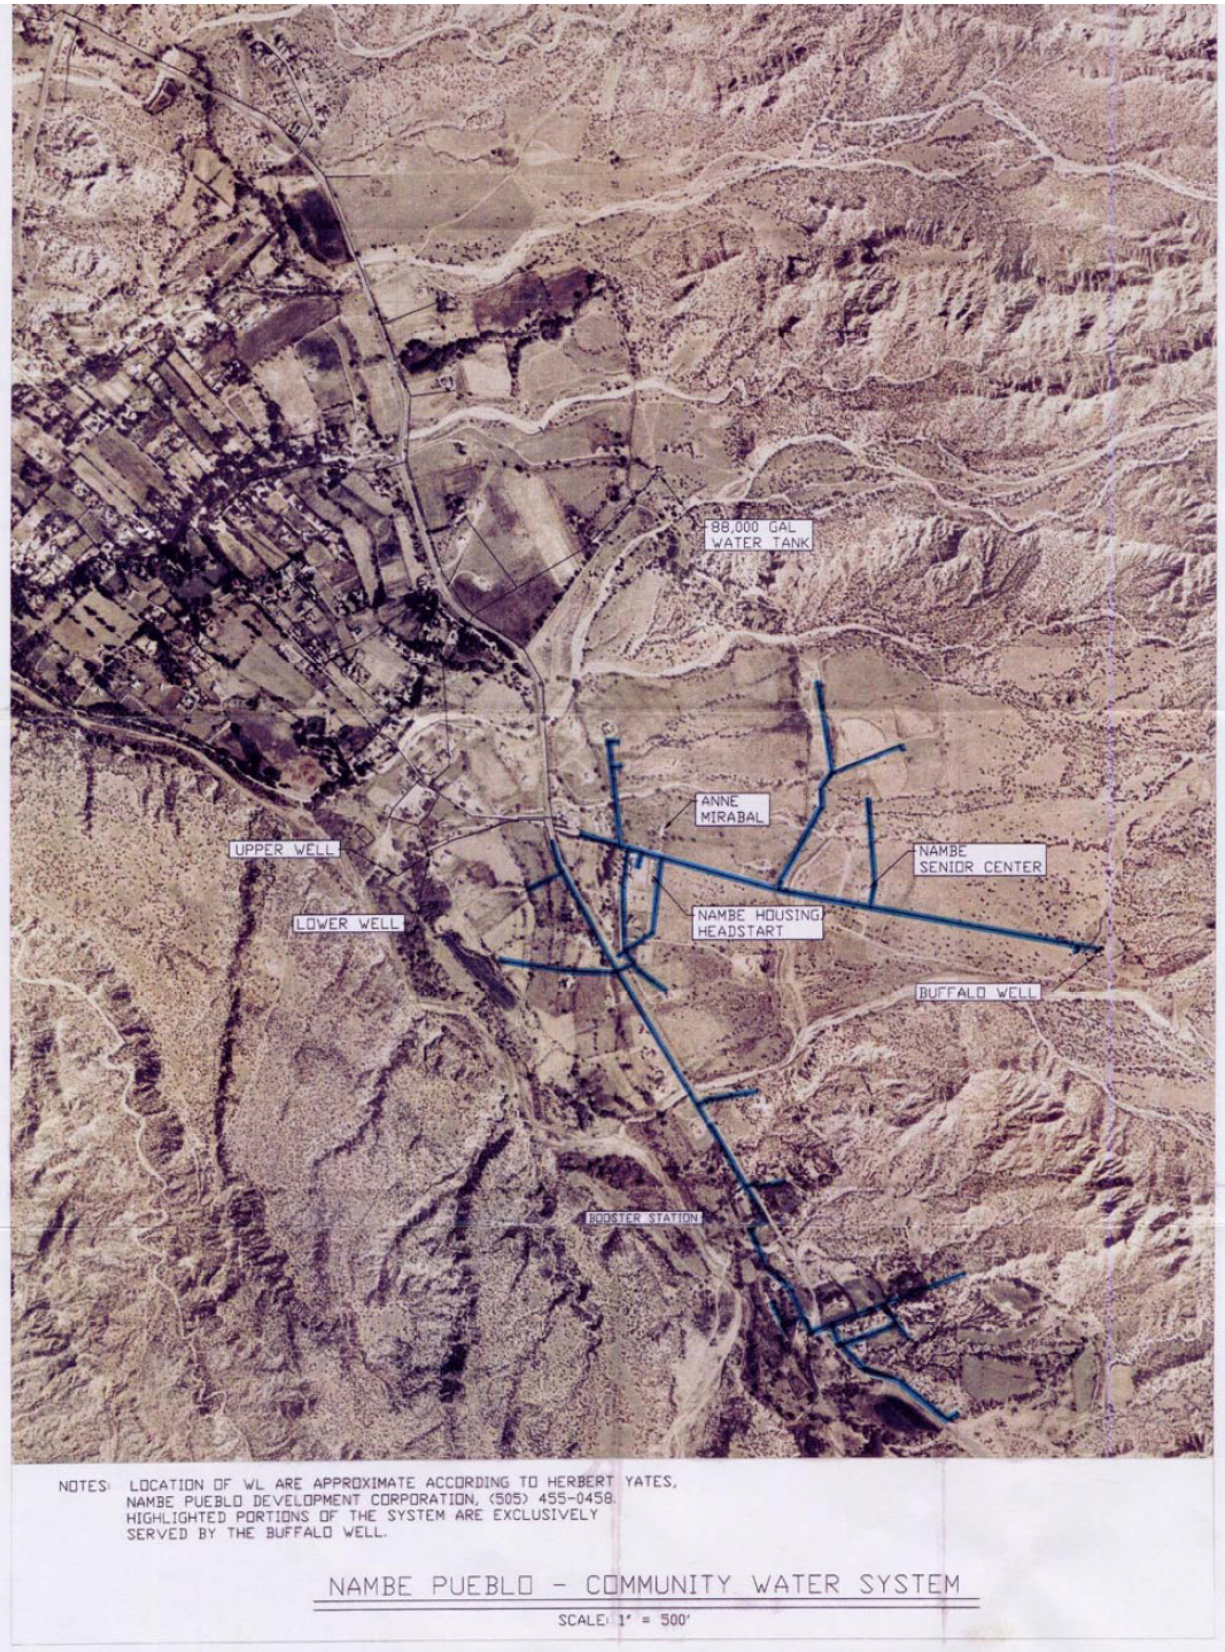
Figure 4-5. Nambe Pueblo Water Distribution System Map

The distribution system is subdivided into the lower and upper zones. The lower zone is supplied by all three wells, whereas the upper zone is served primarily by the Buffalo Well. All three locations for distribution system water sampling were located in the upper zone. Figure 4-5 presents an aerial photograph map of the Nambe Pueblo distribution system.

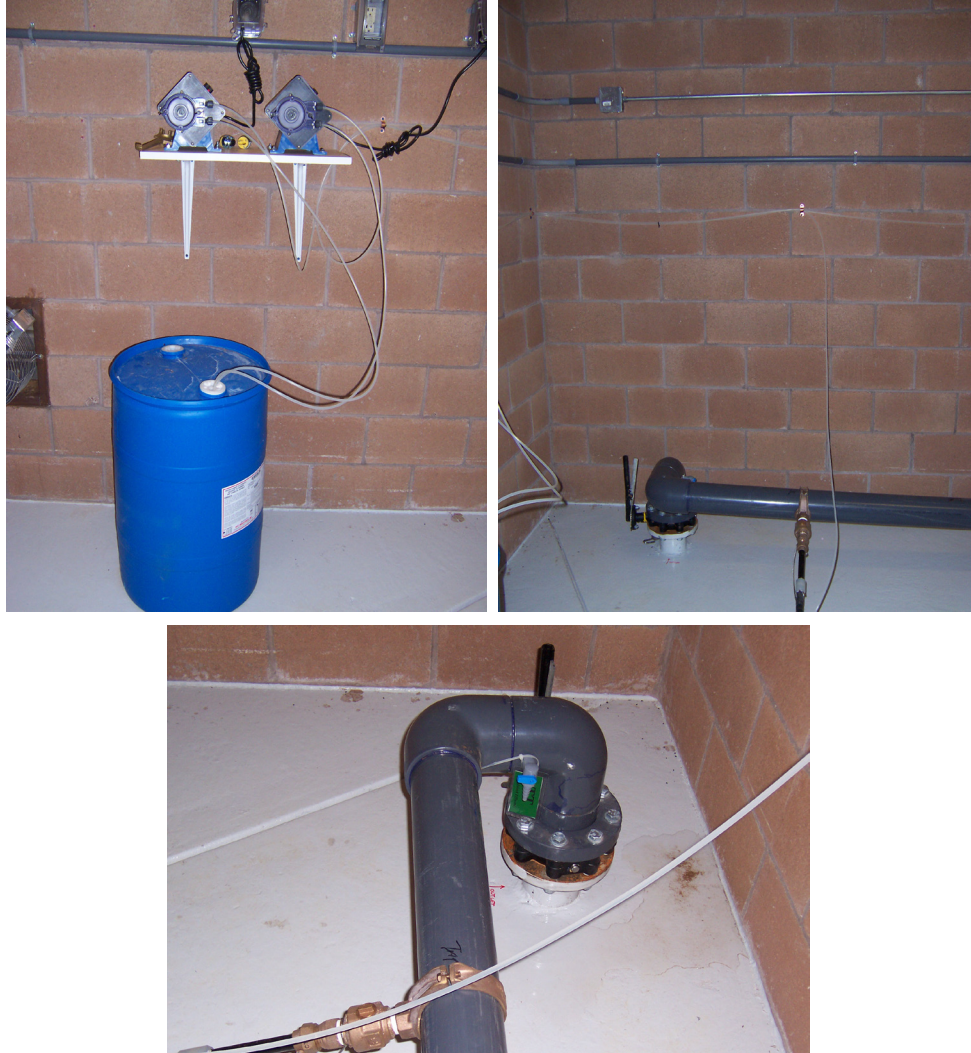
Figure 4-8. Chlorination Feed System

(Clockwise from top left: NaClO storage tank and chlorine metering pumps; Prechlorination injection point; and Post-chlorination injection point)

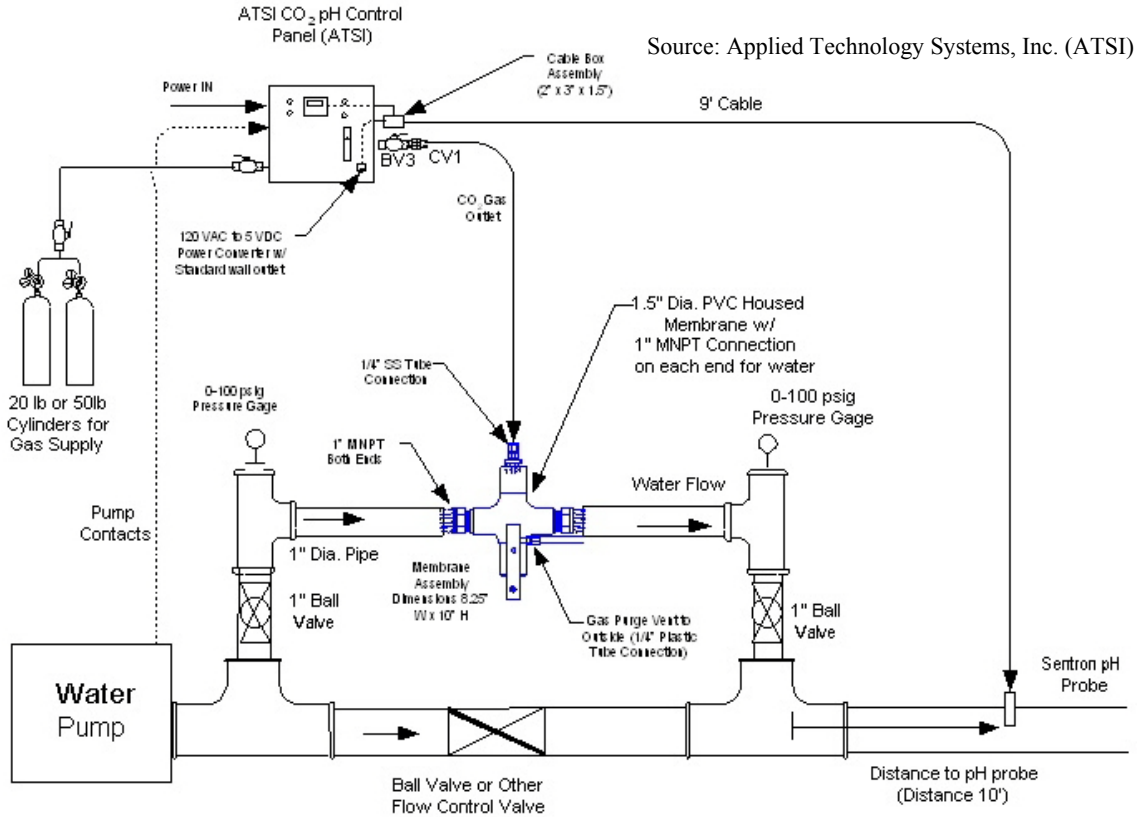
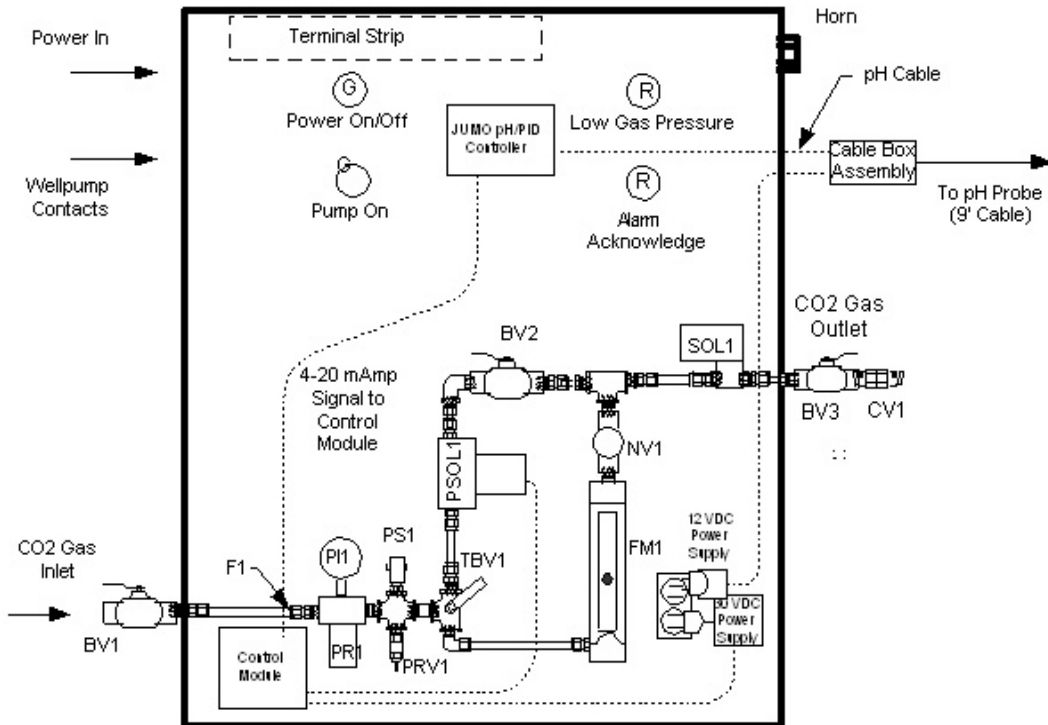
Figure 4-9. Process Diagram of CO₂ pH Adjustment System (top) and pH/PID Control Panel (bottom)

Figure 4-9 presents a process flow diagram of the control system, which is designed to introduce gaseous CO₂ into the water in a side-stream configuration, or a CO₂ loop. Figure 4-10 provides a series of photographs showing various system components.

- Liquid CO₂ in two 50-lb cylinders vaporizes into gaseous CO₂ via a feed vaporizer prior to entering a pH control panel.

- After flowing out of the control panel, CO₂ is injected into water through a Celgard[®] microporous hollow fiber membrane module housed in a 1.5-in stainless steel sanitary cross. Table 4-5 lists the properties and specifications of the hollow fiber membrane module. The sanitary cross is located in a side stream from the main water line to allow only a portion of water to flow through the membrane module to minimize the pressure drop. The membrane introduced CO₂ gas into the water at a near molecular level for rapid mixing/reaction with water to achieve a quick pH response/change.

- Located downstream from the sanitary cross, a Sentron ion sensitive field effect transistor (ISFET) type silicon chip sanitary pH probe with automatic temperature compensation continuously monitors pH levels of treated water and sends signals back to the pH/PID controller for pH control. Data from the in-line pH meter are recorded and stored in a datalogger.

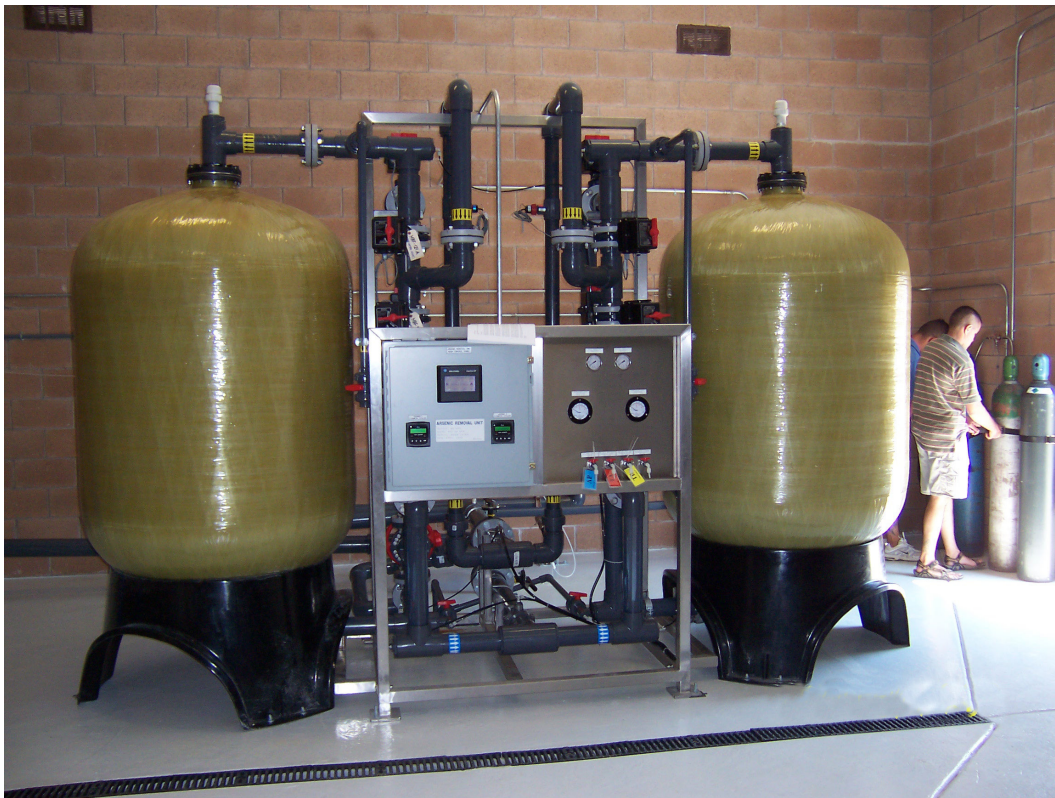
Figure 4-11. Adsorption System Valve Tree and Piping Configuration

Each pressure vessel is interconnected with Schedule 80 PVC piping and five electrically actuated butterfly valves, which make up the valve tree as shown in Figure 4-11. During normal operation, the feed valves and effluent valves are opened and the other six valves are closed to direct water downward through the two adsorptive vessels. During backwashing, the feed and effluent valves are closed and the backwash feed valves and backwash effluent valves are opened to divert water upward through the two adsorption vessels. The butterfly valves are controlled by a Square D Telemechanique PLC with a Magelis G2220 color touch interface screen.

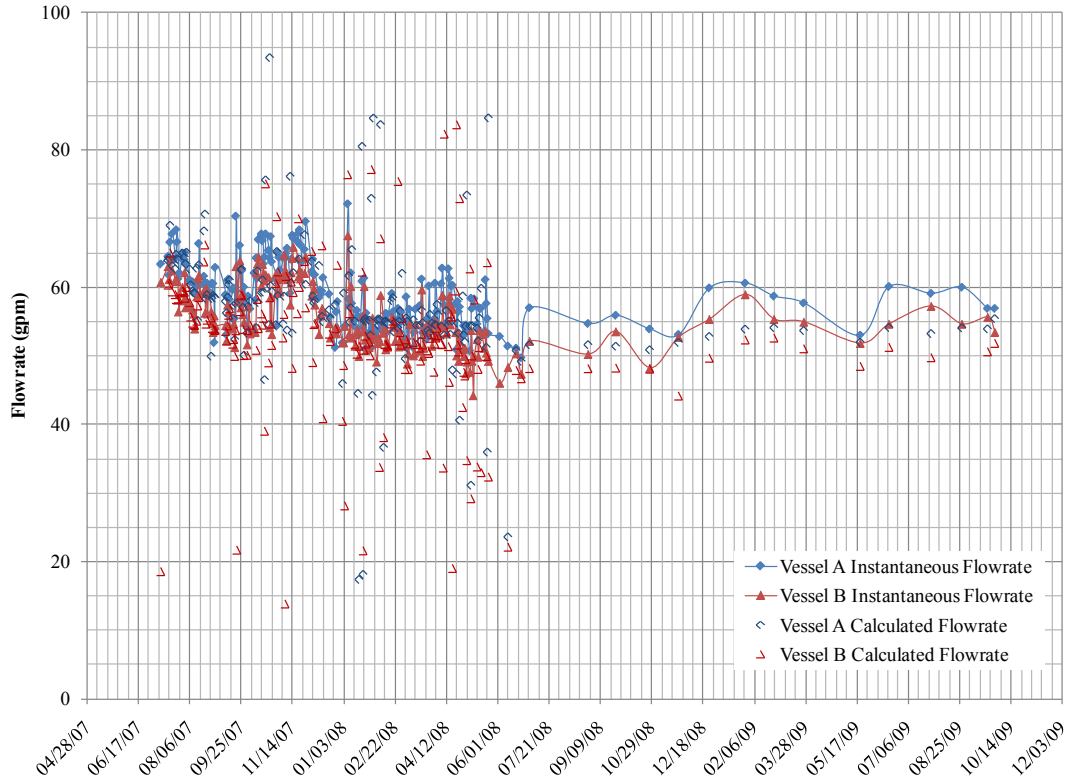
Figure 4-15. System Instantaneous and Calculated Flowrates

Instantaneous flowrates through the treatment system ranged from 97 to 140 gpm and averaged 114 gpm, which was lower than the design flowrate of 160 gpm (Table 4-4). This average flowrate represented an average hydraulic loading rate of 4.5 gpm/ft² and an average EBCT of 4.7 min. The average hydraulic loading rate was lower than the design value of 6.3 gpm/ft², and the average EBCT was longer than the design value of 3.3 min.

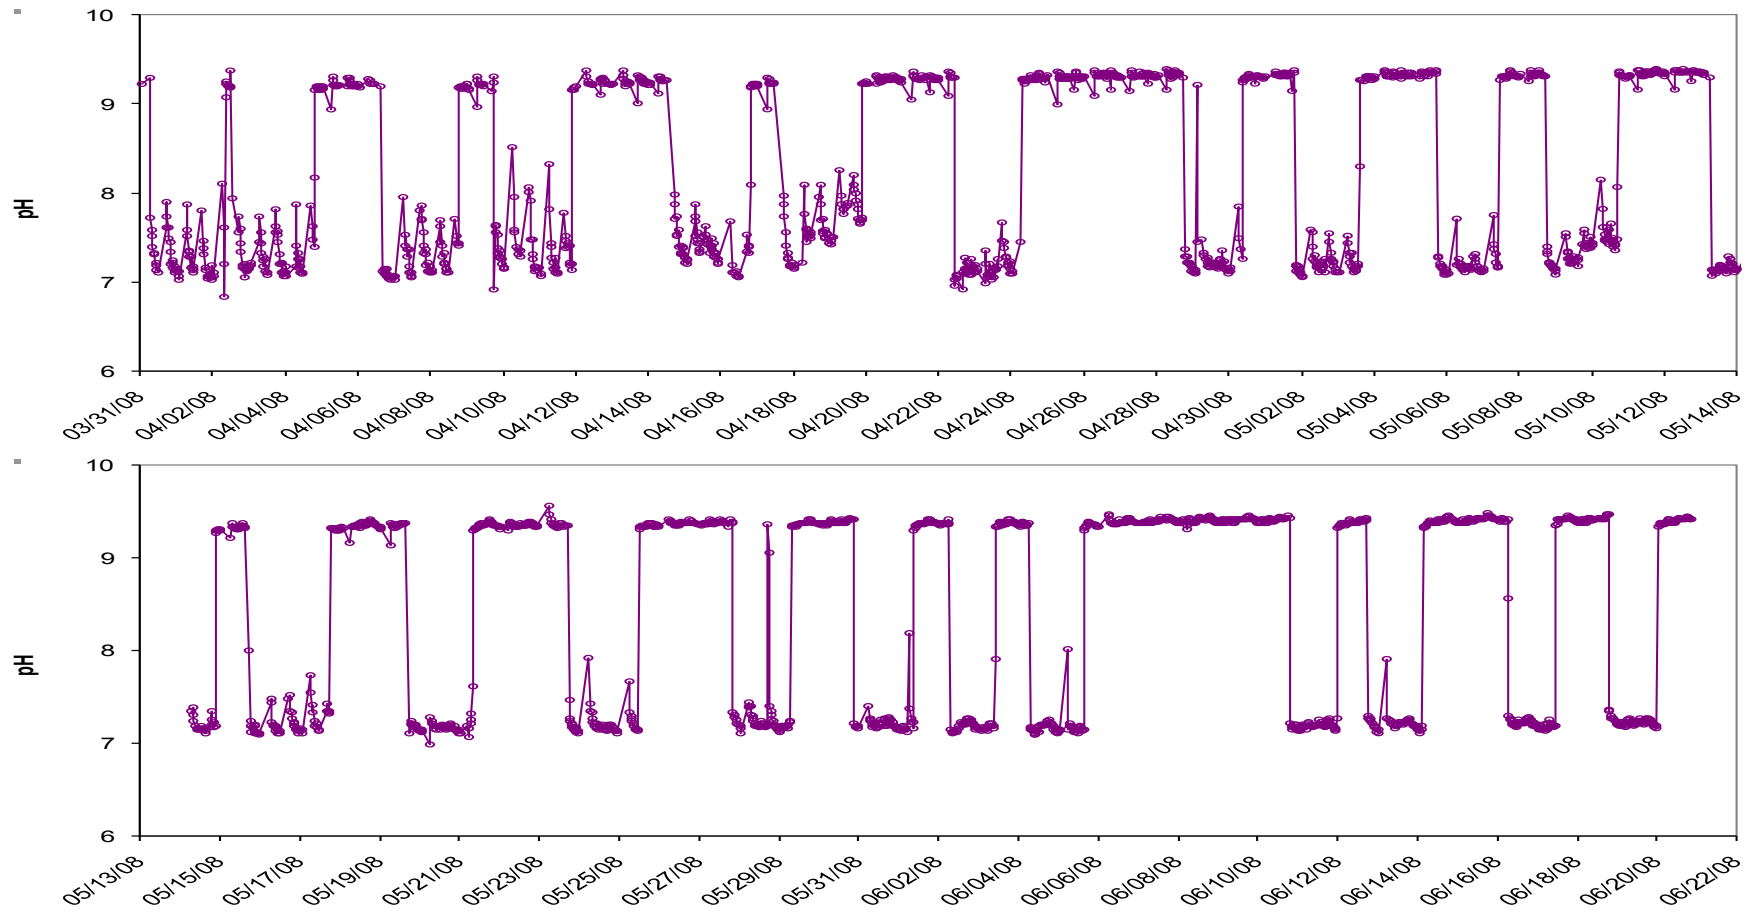
Figure 4-17a. In-line pH Data for Period from March 31 Through June 20, 2008

Shaded areas shown in Figures 4-17a and 4-17b denote the durations when the treatment system operated without pH control. Based on the datalogger, the system operated without pH control for 55.2% of the time during the first period. pH control improved significantly in the second period with only 14.3% of the time operating without pH control. The improvement was probably due to an improved coordination of the plant operator to maintain a more constant CO₂ supply, when analytical results started to indicate that losing pH control might flush adsorbed arsenic and uranium out of the adsorptive media beds (Section 4.5.1).

As also shown in Figures 4-17a and 4-17b, pH values measured by the in-line pH probe and recorded in the datalogger during periods without pH control were higher than those of source water, i.e., 9.0 and 9.1, as presented in Table 4-11. It is possible that the calibration of the in-line pH probe was off; however, due to lack of pH readings from a handheld meter, there were no additional data that might be used to compare the in-line pH probe readings. While the exact pH values might be incorrect due to lack of calibration, it does appear that the probe was able to detect the relative changes in pH during system operation.

Figure 4-19 superimposes effluent arsenic and uranium concentrations with the downloaded in-line pH data during March 31 through June 20, 2008, as plotted in Figure 4-17a. The four concentration spikes observed during this period, i.e., 46.9 and 44.7 µg/L on April 22, 2008, and 43.5 and 41.5 µg/L on May 13, 2008, occurred when the system was operating without pH control. The fact that the concentration spikes had concentrations even higher than those in the system influent (i.e., 31.5 and 40.5 µg/L on April 22 and May 13, 2008, respectively) indicate probable arsenic desorption without pH control.

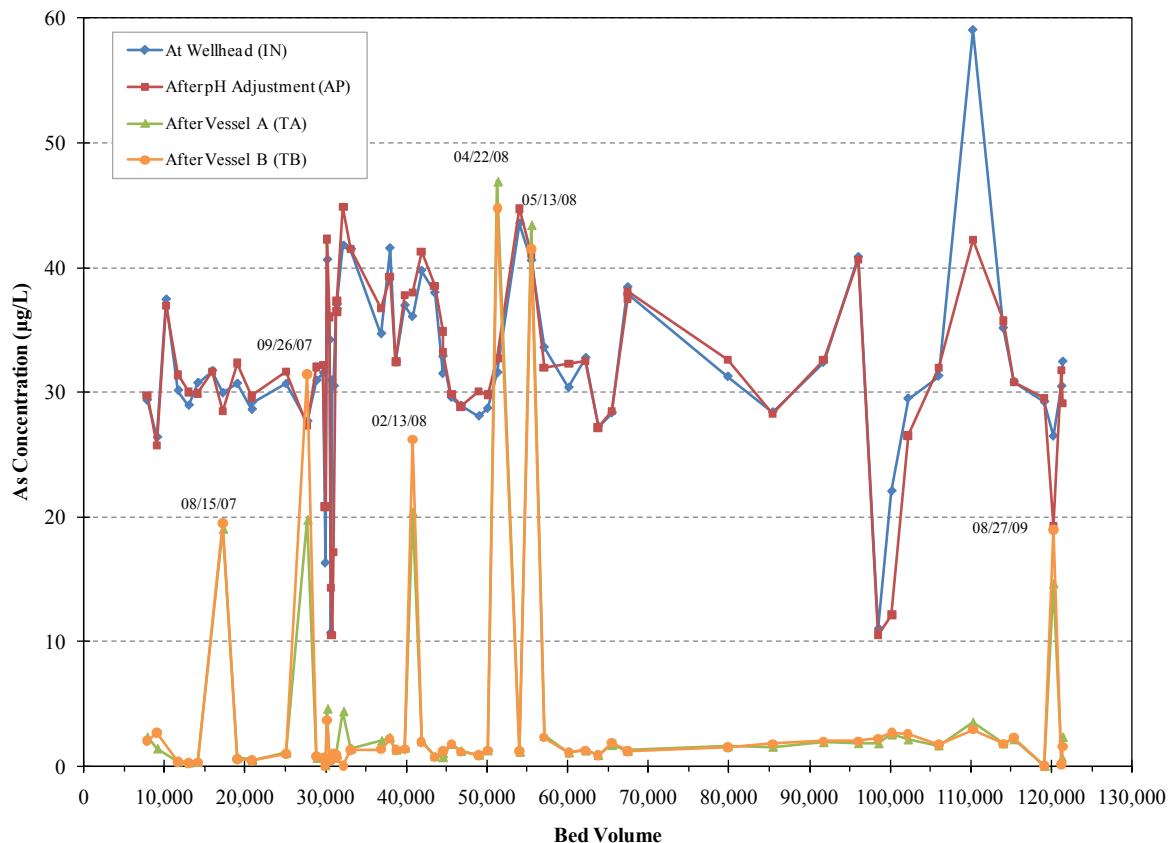
Figure 4-18. Total Arsenic Breakthrough Curves

It is well established that arsenic adsorption on iron-based media performs the best between pH 6.0 to 8.0. As pH increases and approaches the point of zero charge, the availability of adsorption sites on the media surface diminishes. As such, arsenic not only will no longer be adsorbed onto the media but also will begin to desorb. During the performance evaluation study, there were difficulties maintaining a constant CO₂ supply at the site (Section 4.4.2), thus causing repeated losses of pH control prior to adsorption.

Total uranium concentrations in source water ranged from 19.9 to 55.8 µg/L and averaged 39.3 µg/L. Figure 4-20 shows that uranium was removed to <20 µg/L during the entire study period, except for eight occasions, indicating that AD-33 media was capable of removing uranium. The eight occasions with elevated uranium included the six when arsenic concentrations also were elevated (Figure 4-18).

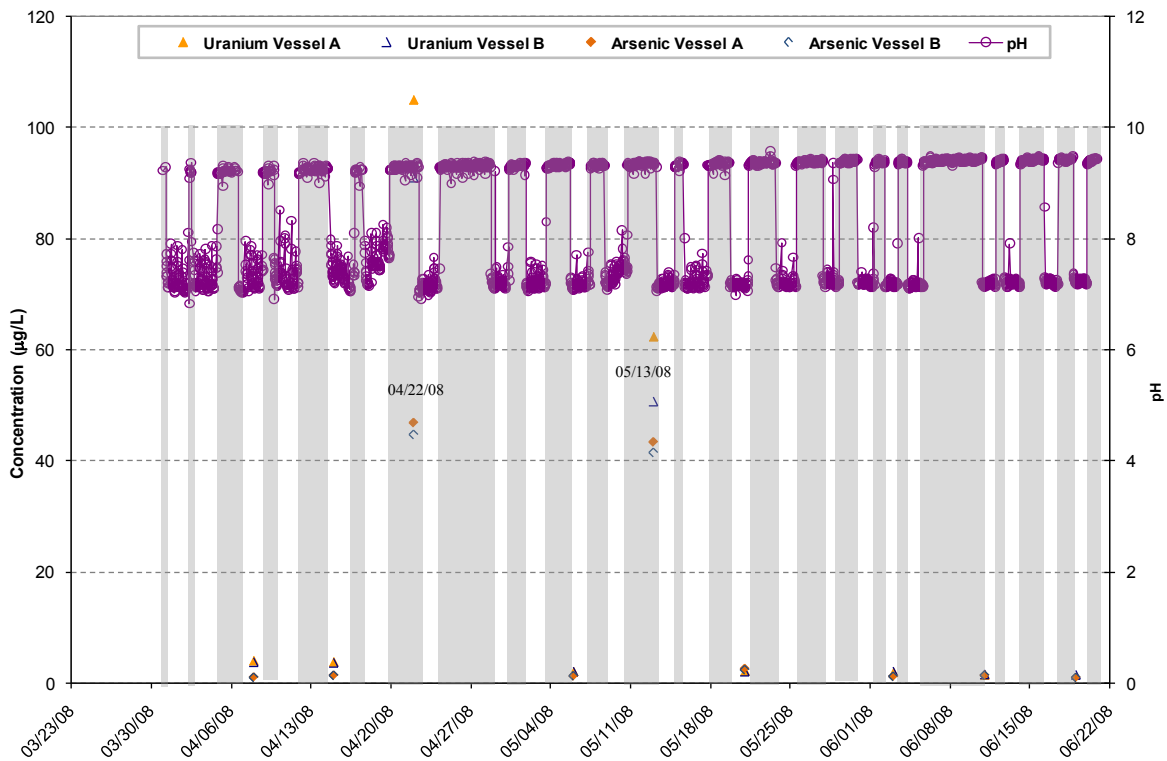
Figure 4-19. Real-time pH values at AP Location vs. Effluent As and U Concentrations

Similar to arsenic, the uranium concentration spikes observed in the system effluent were likely caused by loss of pH control. As shown in Figure 4-19, the four uranium spikes (i.e., 105 and 90.9 µg/L on April 22, 2008, and 62.4 and 50.6 µg/L on May 13, 2008) occurred when pH values at AP were above 9. These concentrations were higher than the corresponding influent concentrations of 41.5 and 37.4 µg/L on April 22 and May 13, 2008, respectively, indicating desorption from the media beds. Similar to arsenic, uranium breakthrough at MCL did not occur during the performance evaluation study.

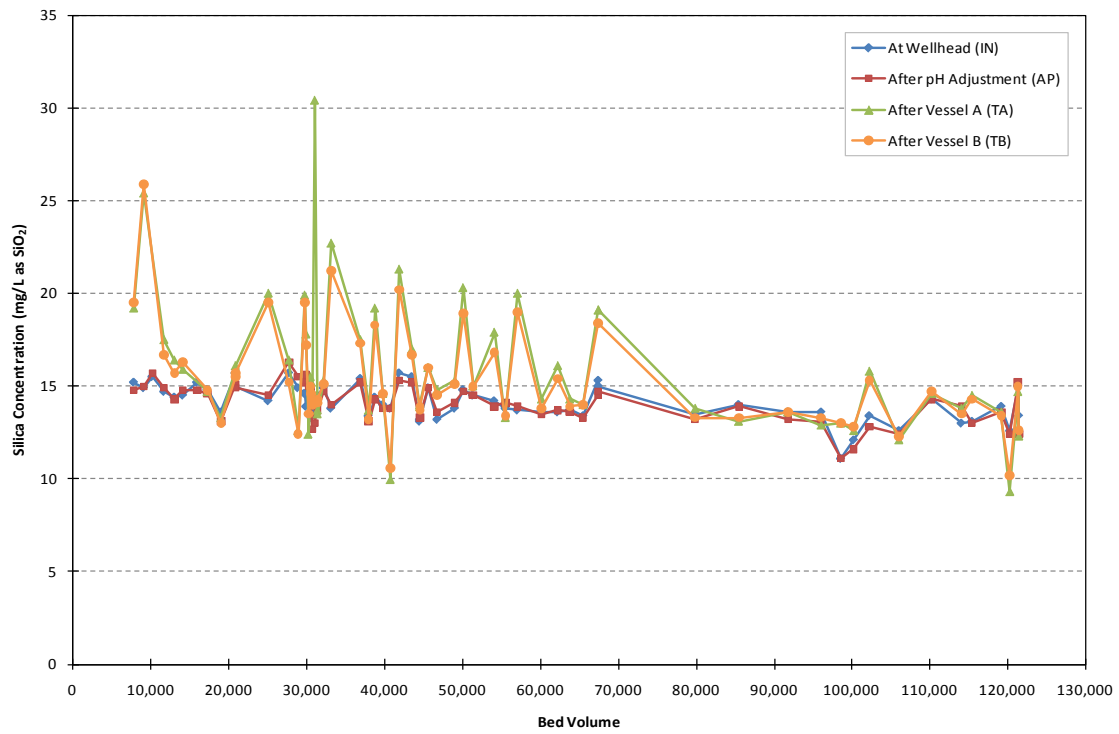
Figure 4-21. Total Silica (as SiO₂) Breakthrough Curves

Competing Anions. Phosphate and silica, which might influence arsenic adsorption, were measured at the five sampling locations across the treatment train. Phosphate concentrations in source water were low, i.e., less than 26 µg/L (as PO₄). Silica concentrations in source water ranged from 11.1 to 15.7 mg/L and averaged 14.1 mg/L. Figure 4-21 presents the silica concentration curves across the treatment train. No silica concentration reduction was observed. Instead, silica concentrations in system effluent were frequently higher than measured in source water, as shown in Figure 4-21. The reason for higher silica concentrations in effluent is unknown.

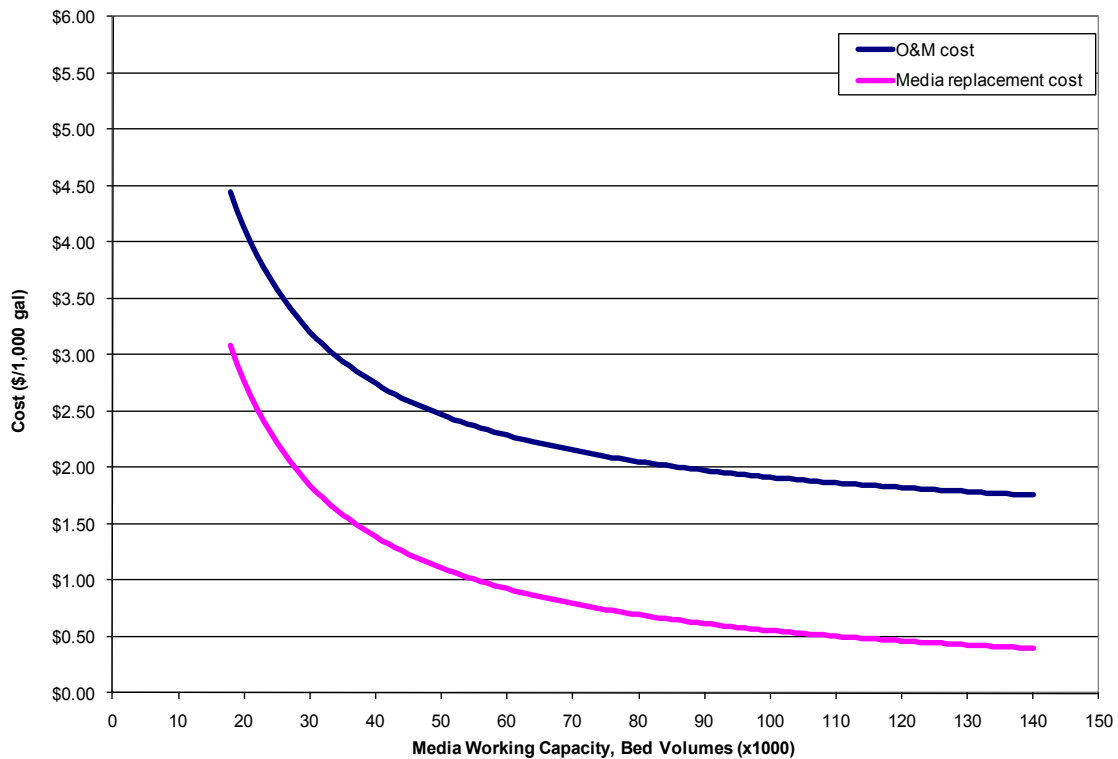
Figure 4-24. Media Replacement and Operation and Maintenance Cost

Note: One bed volume equals 71.2 ft³ (532 gal)
